Periodic Inspection of Nawiliwili Harbor Breakwater, Kauai, Hawaii

Armor Unit Monitoring for Period 1995-2001

Robert R. Bottin, Jr., and Daniel T. Meyers

June 2002

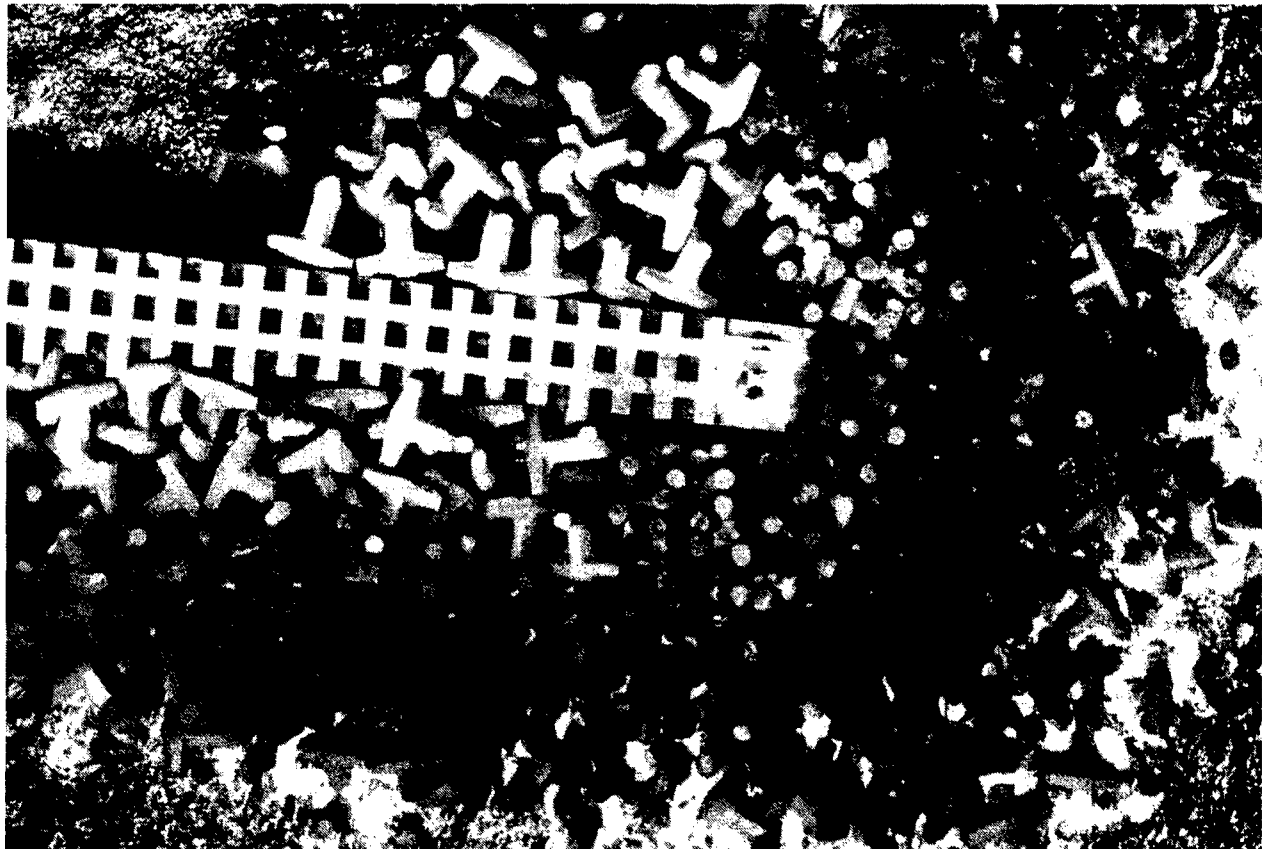
Figure 17. Photo map of head of Nawiliwili breakwater

Photo maps combine the image characteristics of a photograph with the geometric qualities of a map. The image is rectified and free from skewness and distortion, and therefore, precise horizontal measurements may be obtained using an engineer scale. Photo maps were prepared for the outer 260-m (850-ft) length of the Nawiliwili breakwater for the 2001 survey. They were produced on Mylar sheets at a scale of 1:240. An example of a photo map of the head of the Nawiliwili breakwater is shown in Figure 17. In an effort to quantify movement of nontargeted concrete armor units, photo maps obtained for the 1995 and 2001 surveys were compared. It appeared that negligible movement of nontargeted units had occurred between the surveys.

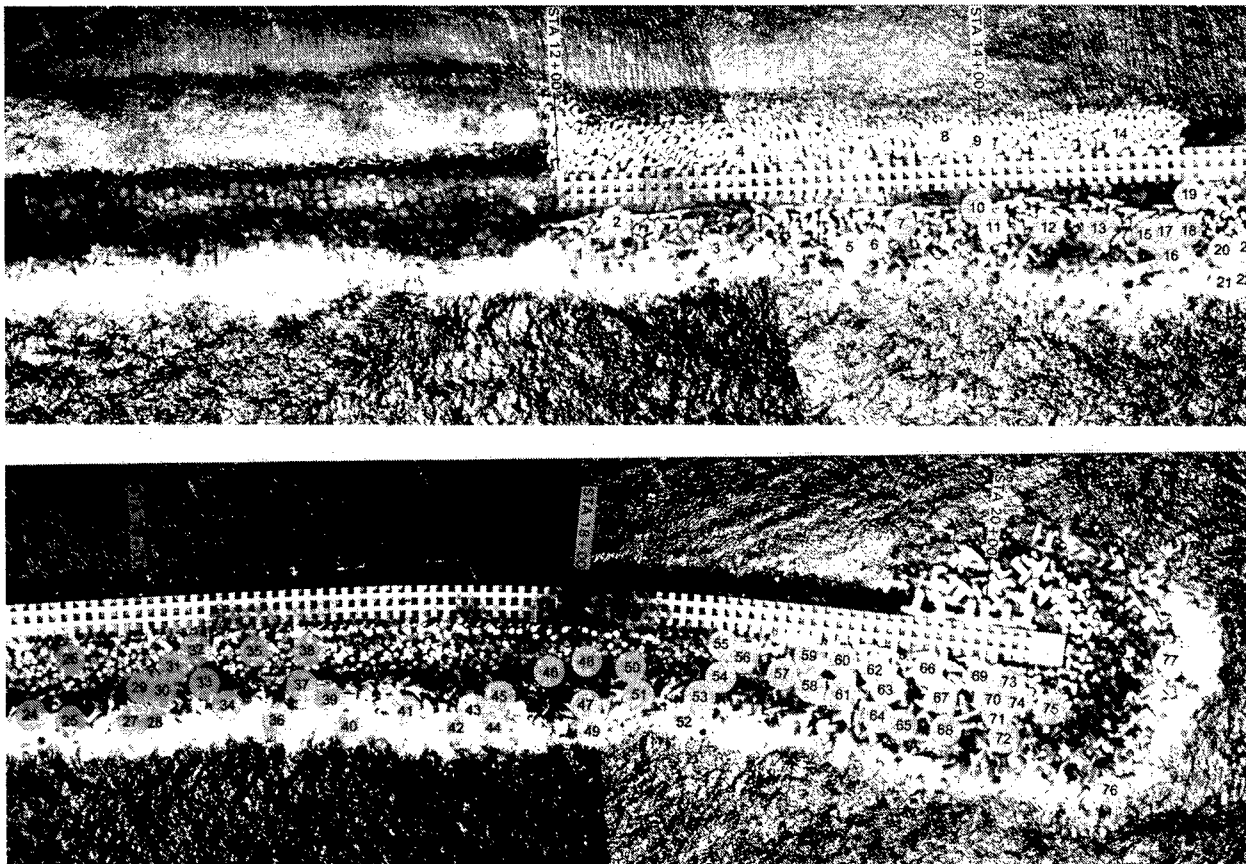
Figure 18. Approximate locations of broken/cracked armor units along outer portion of Nawiliwili Harbor breakwater

The approximate locations of broken/cracked armor units along the outer portion of the breakwater are shown in Figure 18, and detailed data obtained during the broken armor unit inventory are shown in Table 5. Armor unit numbers identified in Figure 18 correspond to those listed in Table 5. As shown, broken units occur along the entire length on the sea side of the structure, but in general, are more concentrated along the seaward end of the breakwater. Fifty-seven percent of the broken units are located on the outer half of the structure, and 27 percent of the broken units are situated on the outer 45.7-m (150-ft) length of the breakwater (sta 19+00 - 20-50). With regard to distance from baseline, the majority of broken units (71 percent) are located between 7.6 and 18.3 m (25 and 60 ft) seaward of the baseline. These units are in the active wave zone.

Of the 77 broken or cracked armor units, 44 were 9,980-kg (11-ton) dolosse, 21 were 16,150-kg (17.8-ton) tribars, 8 were 20,865-kg (23-ton) dolosse, and four were 5,900-kg (6.5-ton) tribars. Considering the types of breaks, 39 percent (17 units) of the 9,980-kg (11-ton) dolosse had mid-shank breaks, 32 percent 14 (units) had shank-fluke breaks, and 29 percent (13 units) had fluke-shank breaks. Of the eight broken 20,865-kg (23-ton) dolosse, four had mid-shank breaks, three had shank-fluke breaks, and one had a fluke-shank break. Of all the dolosse breaks recorded, 75 percent were straight and 25 percent were angled. Of the 21 broken 16,150-kg (17.8-ton) tribars, 16 (76 percent) consisted of at least one leg broken off through the center of the unit. The four broken 5,900-kg (6.5-ton) tribars on the harbor side of the breakwater appeared to have been placed in that condition. They seemed to have been fitted on the crest adjacent to the rib cap.

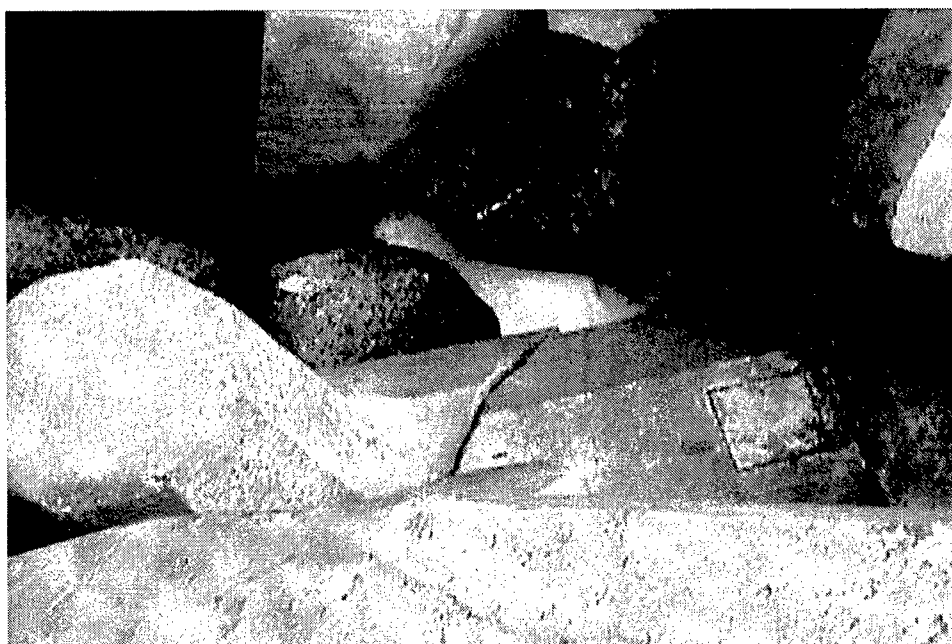
Types of breaks for the dolosse included shank and fluke breaks. These were characterized as mid-shank, shank-fluke (shank broken in vicinity of fluke), and fluke-shank (fluke broken off at junction with shank). Also recorded were straight breaks (broken straight across) and angled breaks (broken at some angle to the dolos limb). For the tribars, types of breaks included those through the center section of the unit where one or more legs were separated from the unit, and those in which just a portion of one of the legs was broken off. Views of representative types of breaks for the armor units are shown in Figures 19-22. Armor units with hairline cracks on one side were not counted, only those that were cracked all the way through were considered a break for recording purposes.

Figure 19. Dolos with mid-shank break

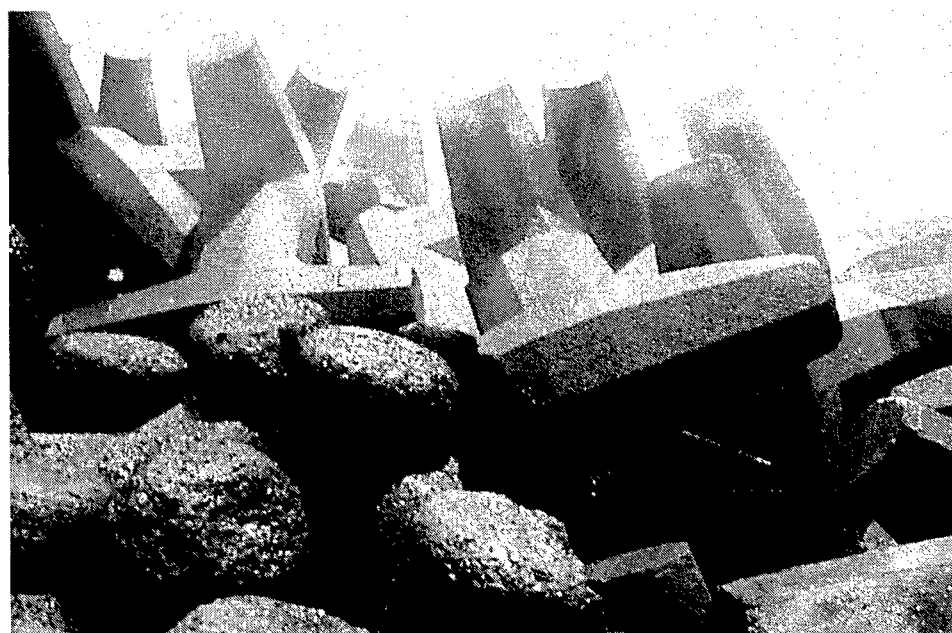
Figure 20. Dolos with fluke-shank break

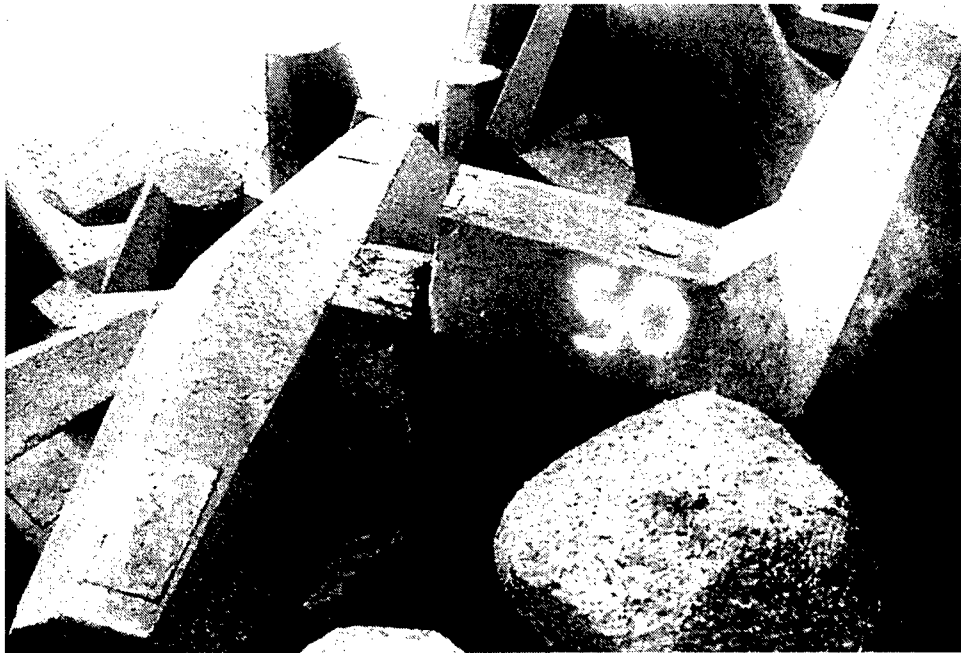
Figure 21. Dolos with shank-fluke break

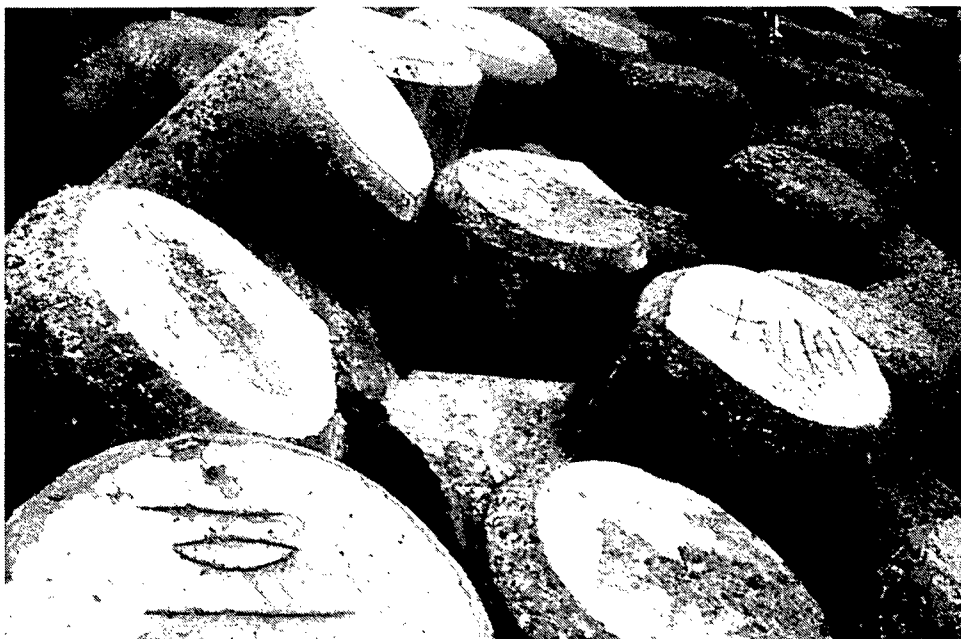
Figure 22. Tribar with break through center section of unit
